**DATE:** JULY 22, 2026  
**TO:** HONORABLE MEMBERS OF THE PUBLIC WORKS SUBCOMMITTEE  
**FROM:** NATHAN HAMBURGER, CITY MANAGER  
**BY:** CHARMAINE YAMBAO, DIRECTOR OF PUBLIC WORKS / CITY ENGINEER  
**SUBJECT:** FINAL DRAFT OF 2026 CITY OF AGOURA HILLS TREE INVENTORY UPDATE

# City Of Agoura Hills

## Tree Inventory Update

MARCH 13, 2026

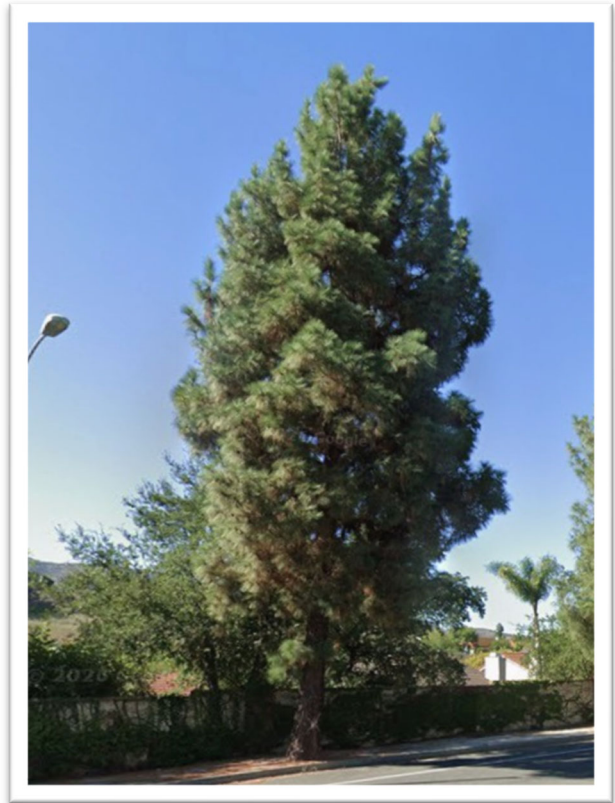
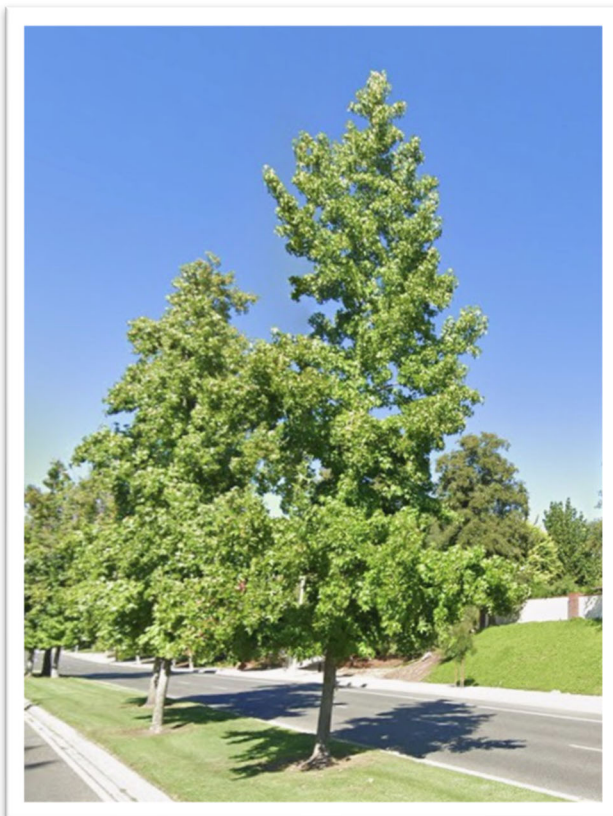
Images 1-3 show examples of trees that would receive a “Grid-Trim” or “Routine Pruning” recommendation.

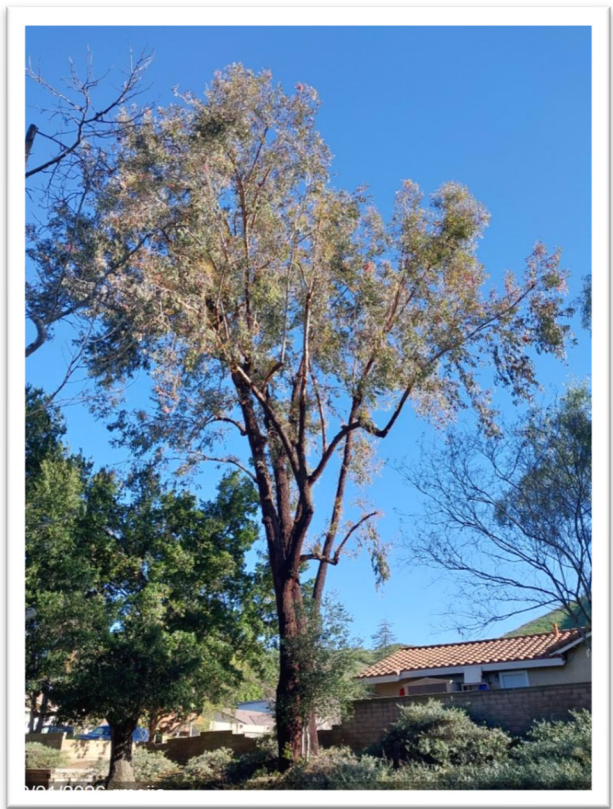
**Trim-Poorly Structured (525 trees).** Trees with this maintenance type have hazardous cracks or structural problems that pose above-normal safety concerns, and the potential for tree failure cannot be mitigated through routine pruning. Other examples of poorly structured trees are those

with actively separating included bark at a primary branch attachment, which greatly increases the potential for future limb failure. *Native: 247, Non-Native: 278.*

Images 4-6 show examples of trees that would receive a “Trim-Poorly Structured” recommendation.

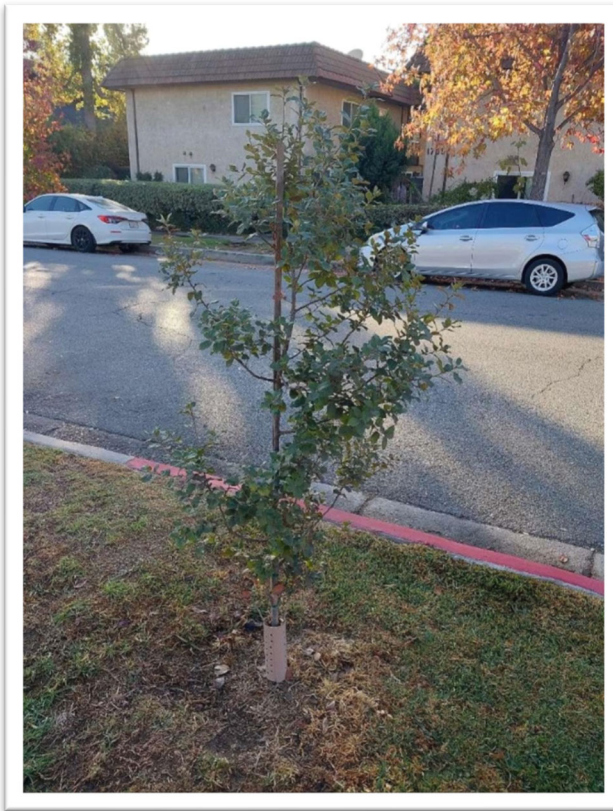
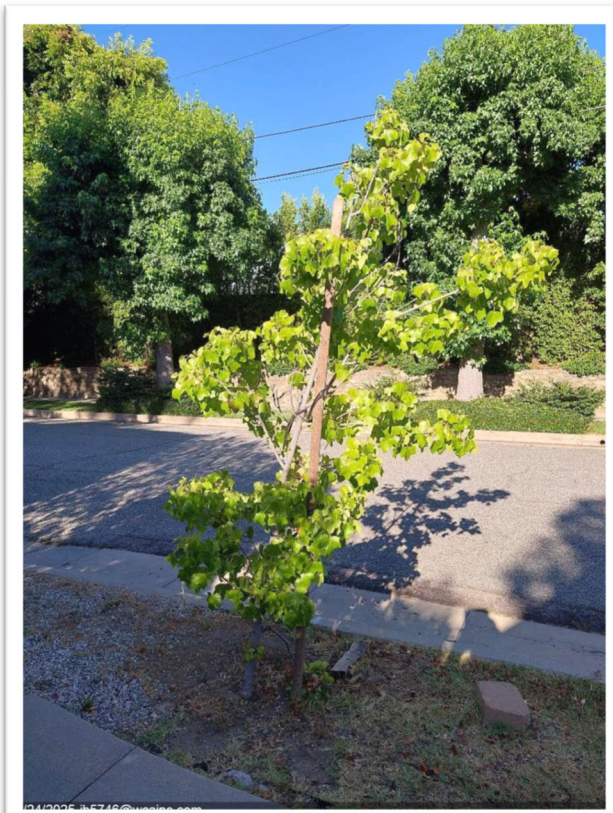
Images 7-9 show examples of trees that would receive a “Young Tree Maintenance” recommendation.

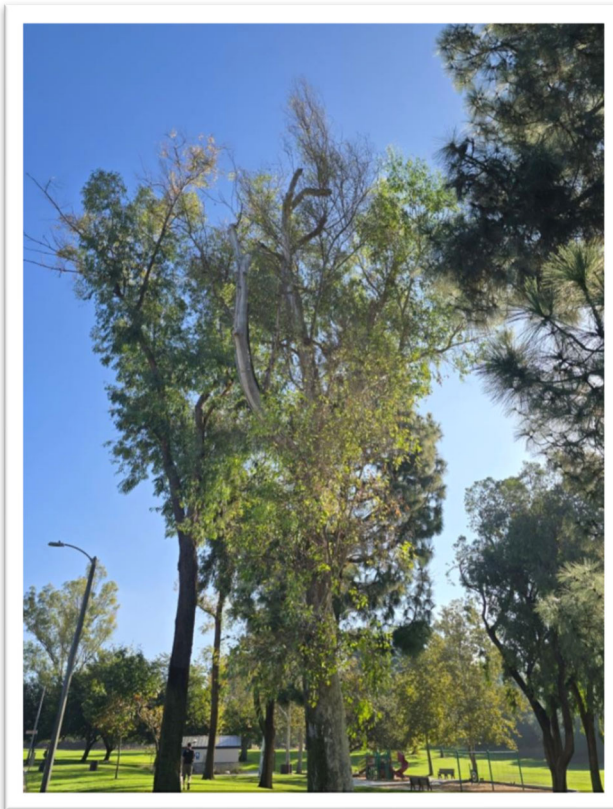
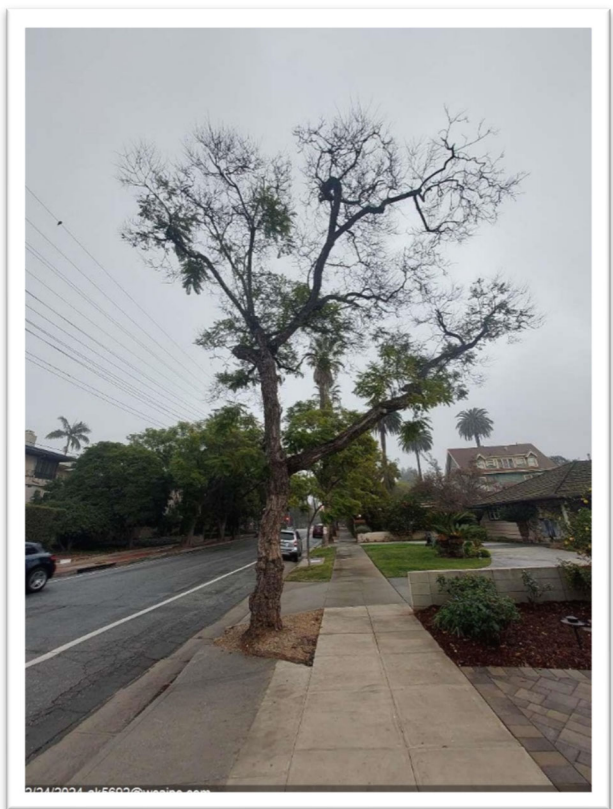
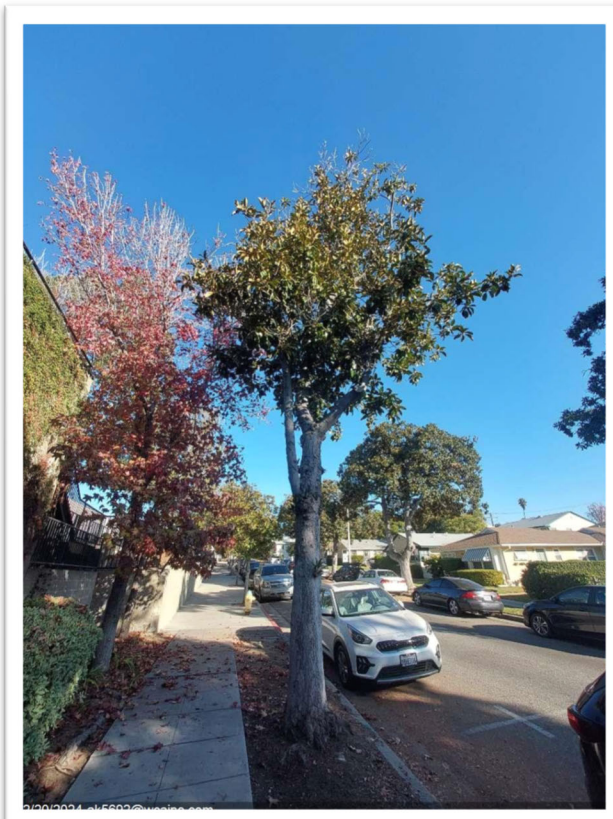
**Patrol for Disease or Decline (360 trees):** Trees in this category are in decline due to a number of possible reasons, including environmental conditions, pests, disease problems, or natural senescence. At the time of data collection, these trees had not yet reached the point where removal was necessary. In some cases, the condition of these trees may be improved by trimming, watering, or the application of other plant health care practices. It is recommended that these trees undergo disease identification and, if necessary, treatment prescription, and be patrolled to determine the timing of treatment and application, or when removal might be warranted. Non-native trees (or those with a Moderate or High Fire Risk Rating) in this classification may also be considered for removal, and a reexamination of these trees is recommended. *Native: 112, Non-Native: 248.*

Images 10-12 show examples of trees with symptoms that would receive a “Patrol-Diseased Declining” recommendation.

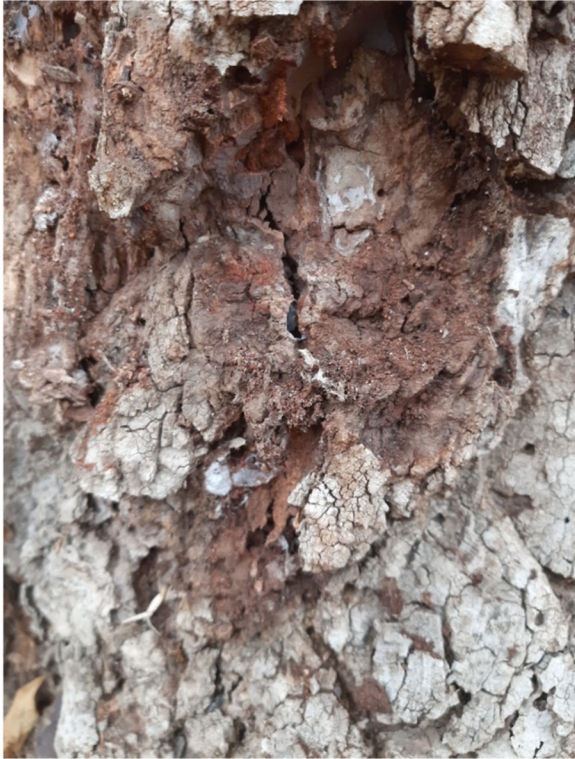
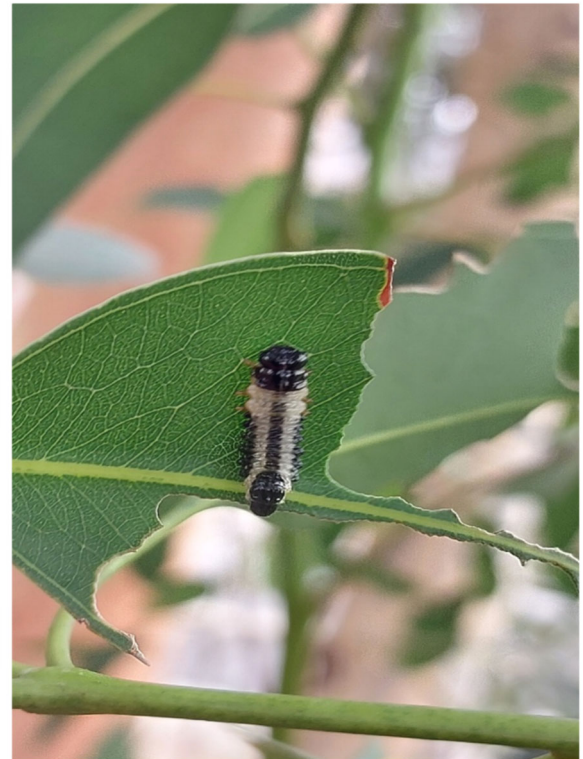
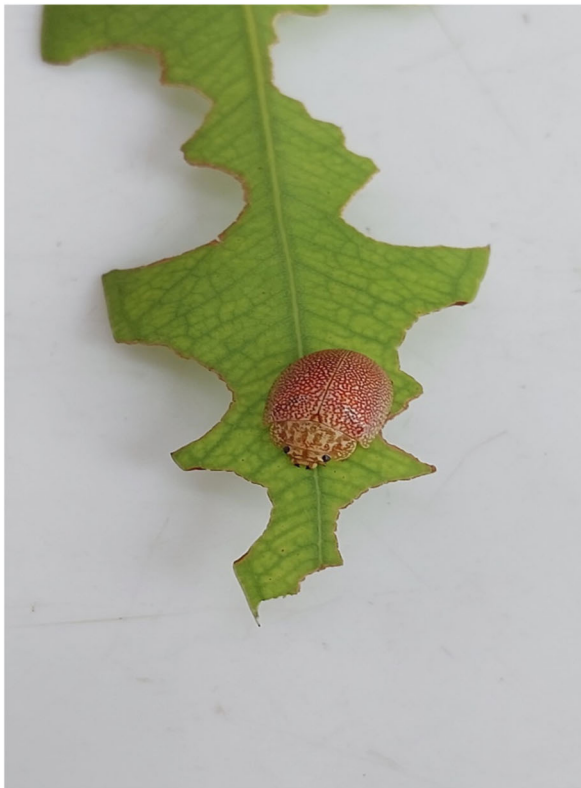
**Inspect: Insect Infestation (232 trees):** Trees assigned this recommendation are exhibiting signs or symptoms of active or potential insect infestation, such as canopy thinning, leaf discoloration, exit holes, frass, or abnormal dieback. Early evaluation, treatment, and intervention may improve tree health by controlling or eradicating insects and reducing the potential for spread to adjacent trees. *Native: 137, Non-Native: 95.*

Images 13-15 show examples of trees with symptoms that would receive an “Inspect-Insect Infestation” recommendation.

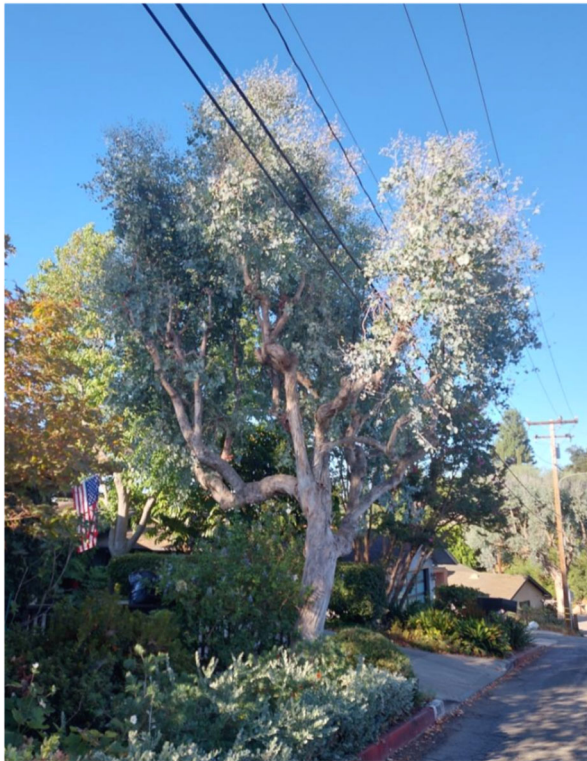
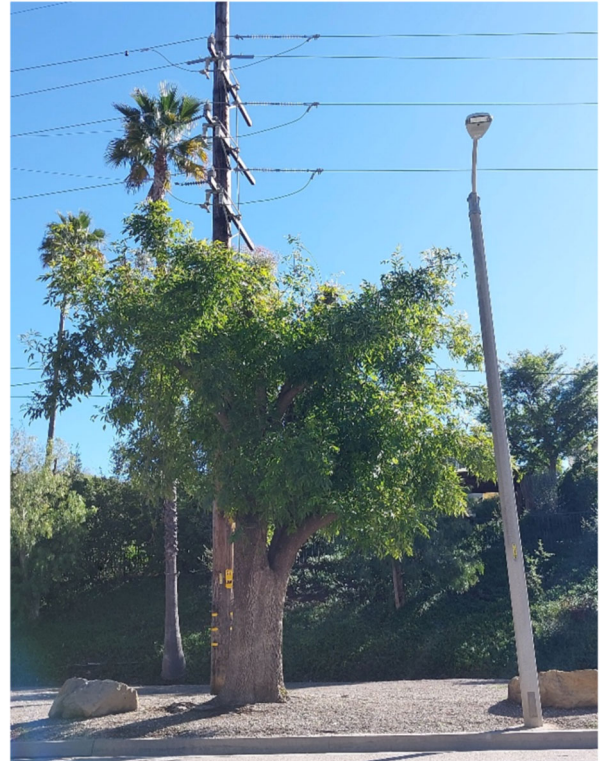
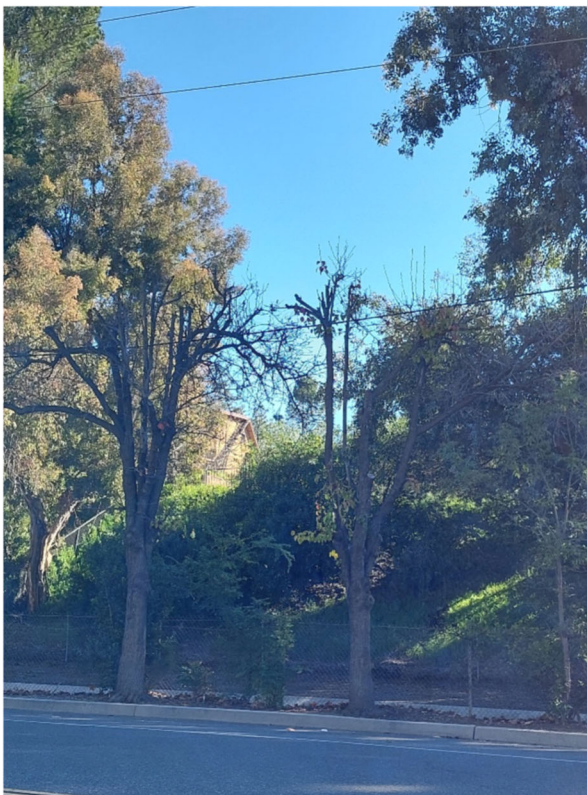
- **Tree Spacing Criteria & Overhead Spacing Criteria (12 trees):** These trees do not have enough growing space in the city right-of-way. Crowding or inappropriate locations often result in displaced hardscape, which can pose a serious trip-and-fall hazard to the public. Trees in this category may be planted too close to one another or to objects such as hydrants, poles, or meters, or may be influenced by overhanging private trees. *Native: 0, Non-Native: 12.*

Images 16-18 show examples of trees would receive a “Removal-Spacing Criteria” recommendation.

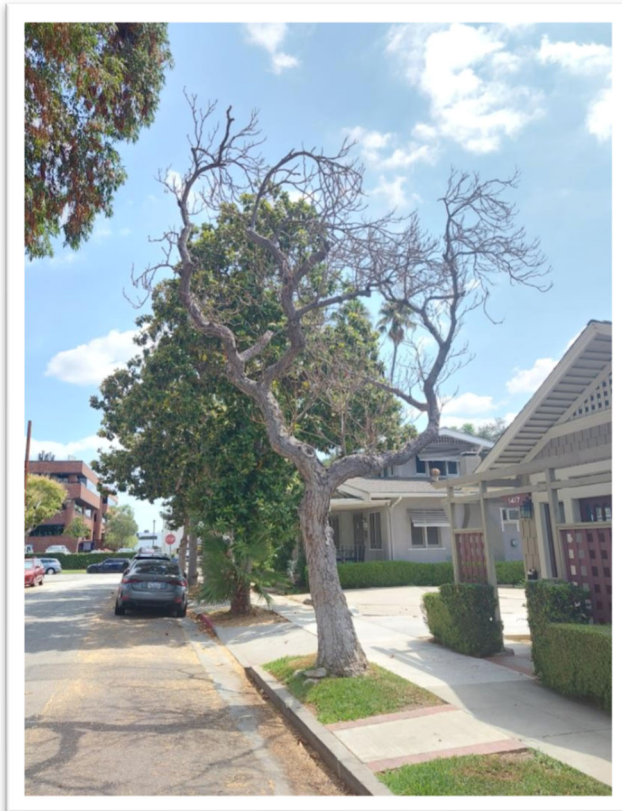
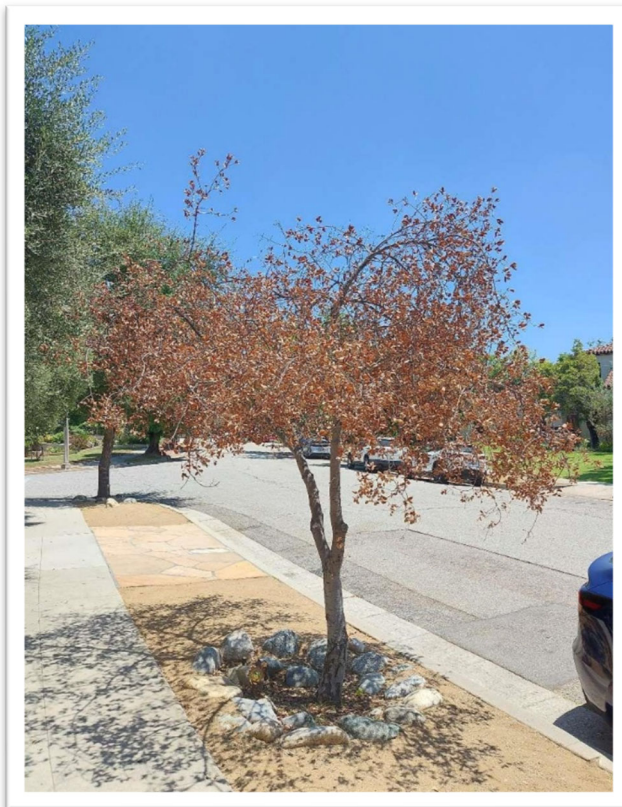
- **Dead & Dead Small Trees (21 & 31 trees):** Dead trees are identified by their species names, where the species can be determined. If they are not identifiable, they are called "Dead Tree." All dead trees should be scheduled for immediate removal. However, depending on their location, some of these trees may also be considered for preservation to create suitable wildlife habitats where public safety conditions are not a concern. *Native: 33, Non-Native: 19.*

Images 19-21 show examples of trees that would receive a “Removal-Dead” recommendation.

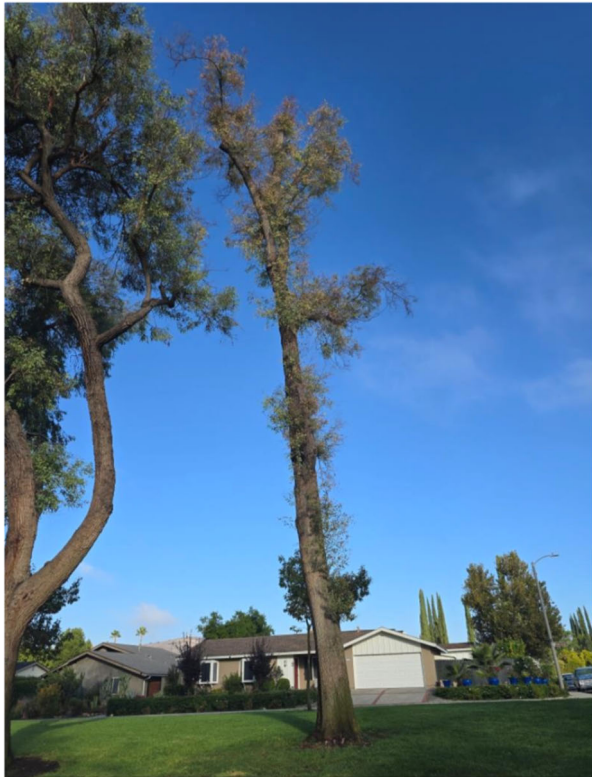
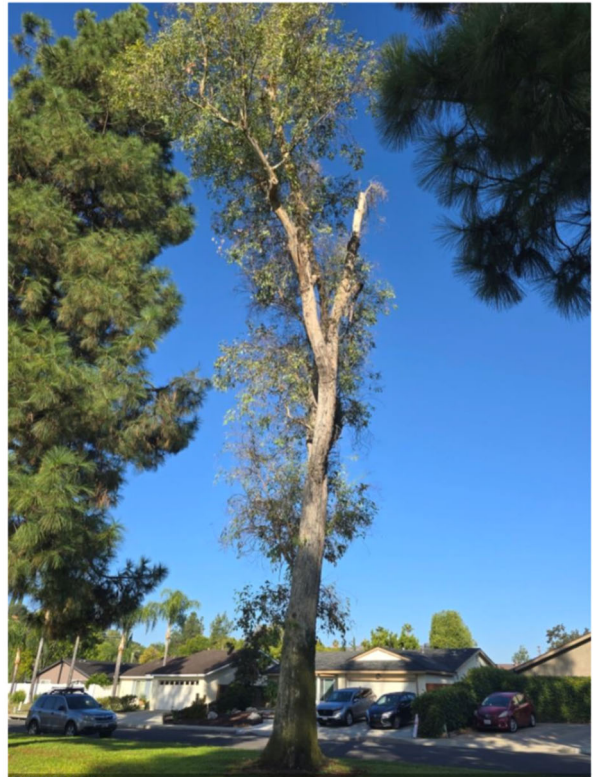
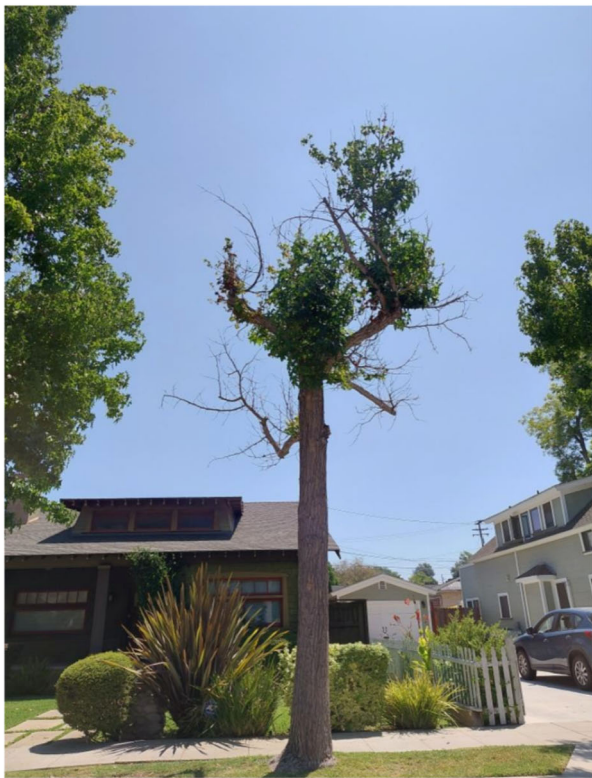
- **Diseased or Declining (39 trees):** Trees with this recommendation are diseased or declining to a point beyond any management strategy to recover them. It is recommended that these be removed immediately to reduce the potential spread of problems and to address public safety concerns when targets are in close proximity. Some of these might also be considered for preservation to create suitable wildlife habitat where conditions for public safety are not a concern. *Native: 12, Non-Native: 27.*

Images 22-24 show examples of trees that would receive a “Removal-Diseased or Declining” recommendation.

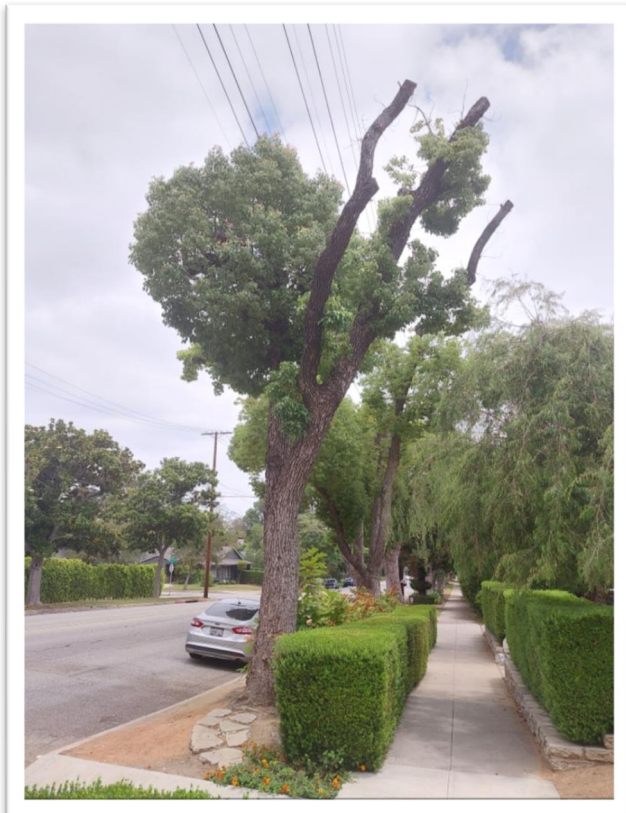
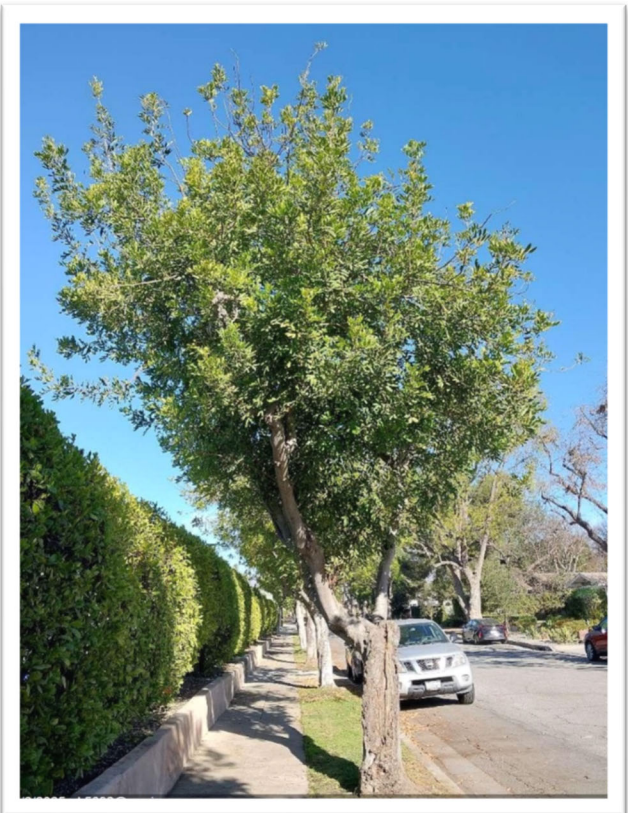
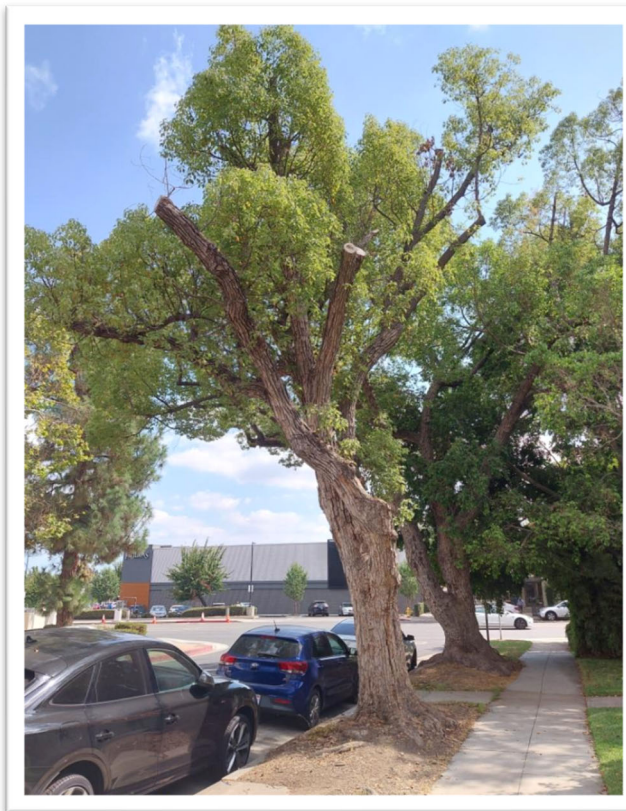
- **Poorly Structured (6 trees):** These are trees that have hazardous cracks or structural problems that present above normal safety concerns, and the potential for tree failure cannot be mitigated through pruning alone. Other examples of poorly structured trees are those with actively separated included bark at a primary branch attachment, which greatly increases the potential for future limb failure. *Native: 1, Non-Native: 5.*

Images 25-27 show examples of trees that would receive a “Removal-Poorly Structured” recommendation.

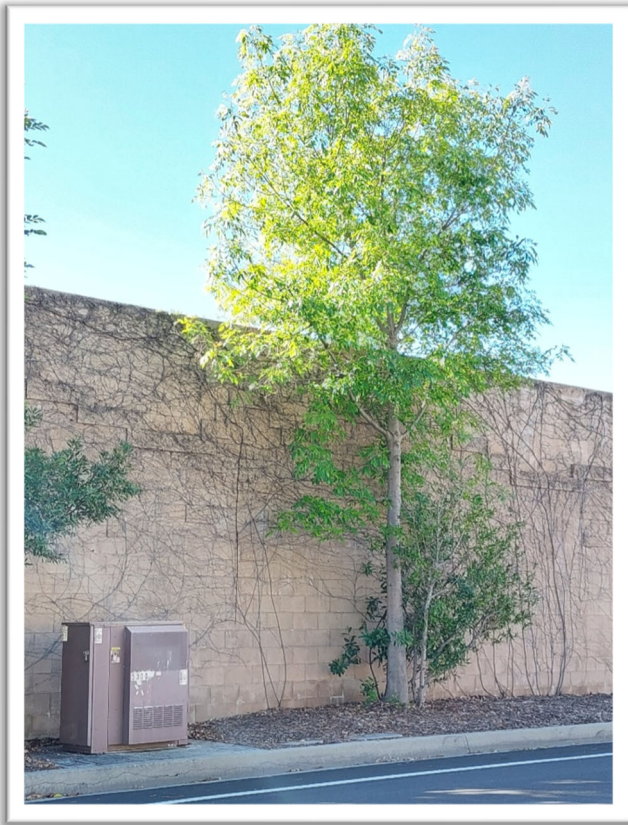
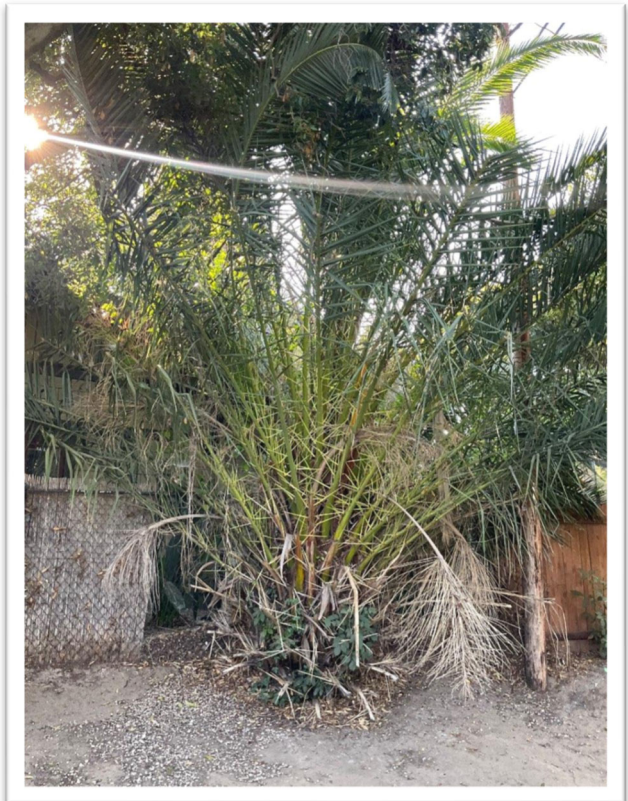
- **Seedling or Volunteer (26 trees):** Trees meeting these criteria were not intentionally planted by the City and are inappropriate for the current site conditions. These may be trees planted by homeowners, grown via seeds from surrounding trees, or from bird droppings. *Native: 5, Non-Native: 21.*

Images 28-30 show examples of trees that would receive a “Removal-Seedling/Volunteer” recommendation.
